## DEGRADATION OF AGRICULTURAL LANDS CAUSED BY EROSION (CASE STUDY, VERMES COMMUNE, CARAS-SEVERIN COUNTY)

**MAZĂRE V<sup>1</sup>., STROIA M.S.<sup>1</sup>, MIHUȚ CASIANA<sup>1</sup>**

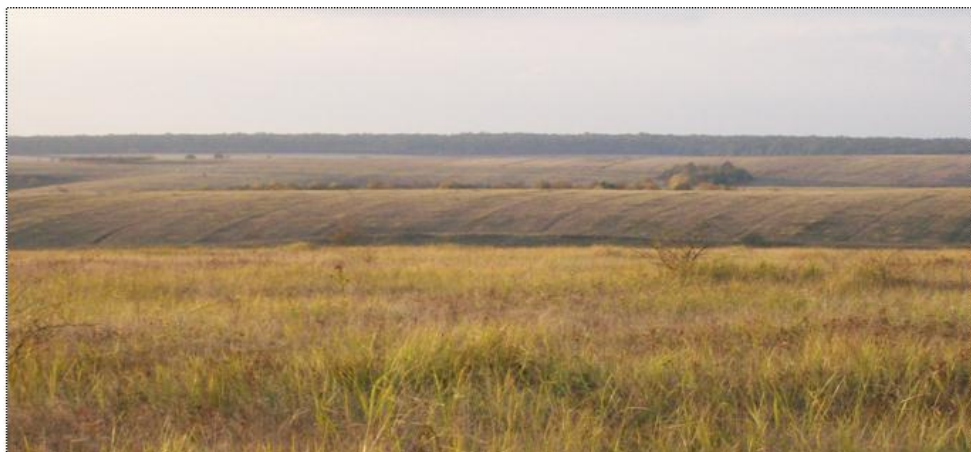
**Fig. 1 Prolonged crystalline horsts on the territory of Vermeș commune**

Within relief of the zone, as witnesses of the strong tectonic movements and of connection existing between these relief forms and Central Banat Mountains, remained two prolonged crystalline horsts which have their base buried with materials detached from their own bodies.

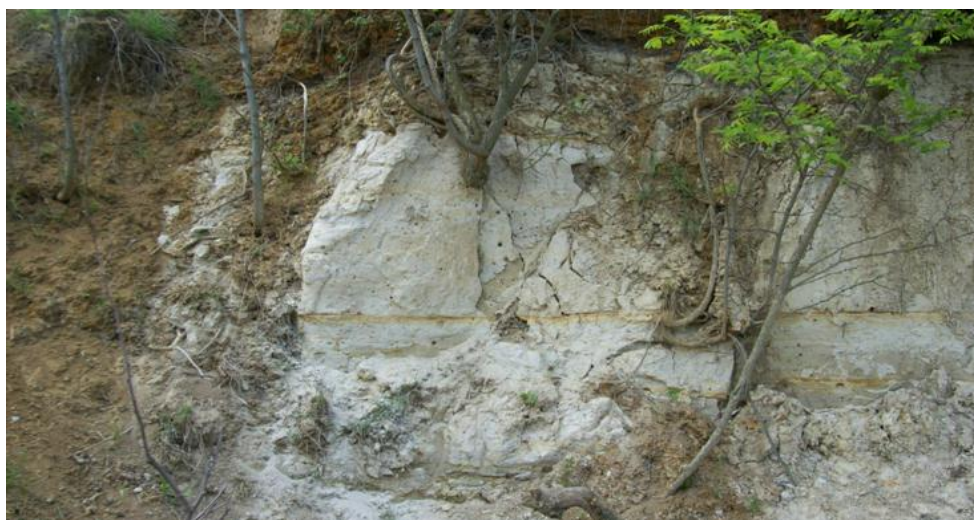
**Fig. 2 Quaternary parental material (Ogașul Lupului), village Izgar, Vermeș commune**

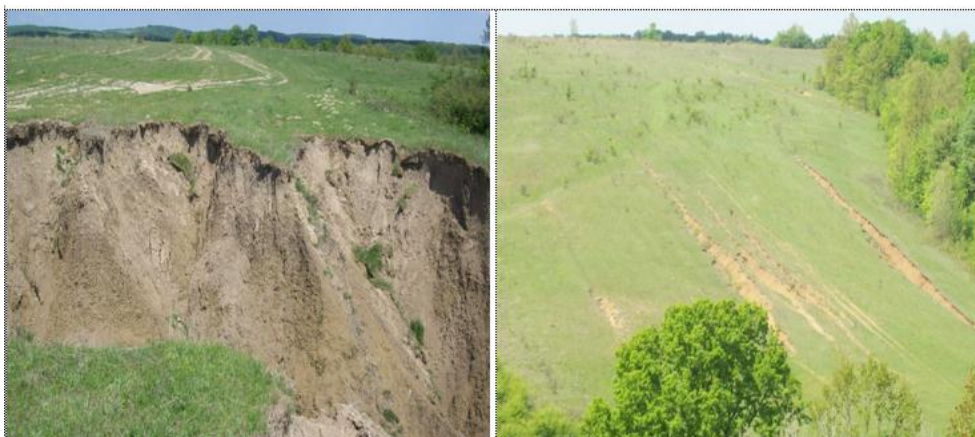
Erosion decapitated in numerous parts the superficial soil profile. Depth erosion is represented by ditches of various sizes and gully erosions (2).

**Fig. 3 Ditches and gully erosions caused by erosions on the territory of Vermes commune**

Depth erosion is concomitant with surface erosion, transition is gradually done. By concentration, the surface drainages give canals in „V” or „U” shape, and passing through a hardly erodable horizon they start to get large (2).

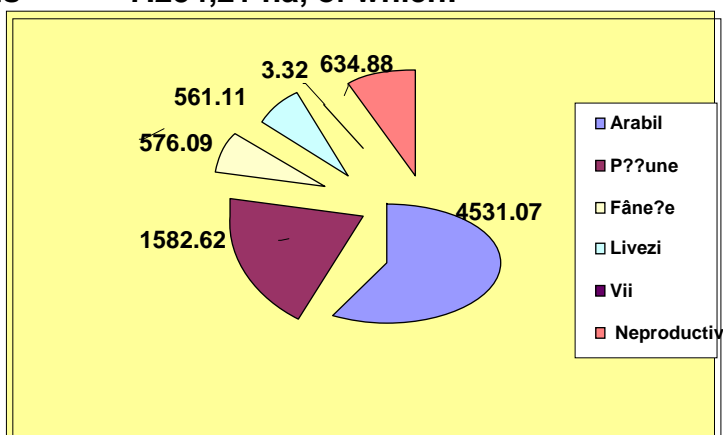
**Total agricultural lands = 7.254,21 ha, of which:**

- Arable = 4.531,07 ha
- Pastures = 1.582,62 ha
- Hayfields = 546,09 ha
- Orchards = 561,11 ha
- Vineyards = 33,32 h
- Other terrains (unproductive) = 634,88 ha

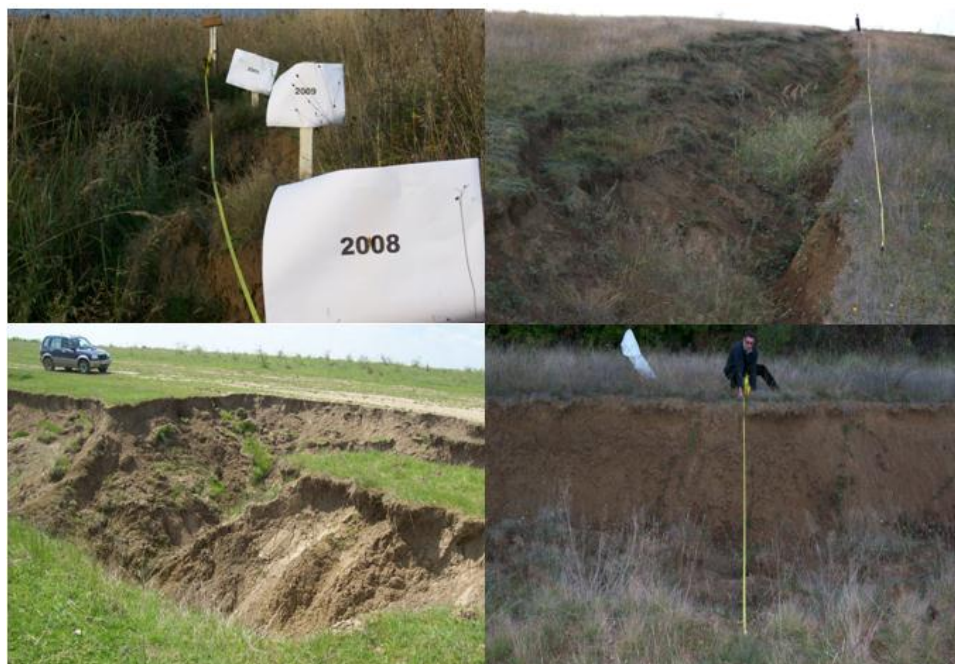
Sizes of ravines ranges from 0,5-219m length to 15,5m width, with maximal depth by 3,65 m.

**Fig. 4** Field measurements of erosion within territory of Vermes commune

The annual mean precipitations were: 2008-725mm; 2009-750mm; 2010-710mm; 2011-720mm. Due to precipitations it can be observed in image how was sculpted the erosion forms in the shores of ravine.

Evolution of ravines within studied area significantly increased in 4 years of observations, approximately with 1-3m yearly as length, 0,5m depth, and 0,70m width, determining degradation of soil properties under aspects concerning the fertility.
